February 21, 2017

Re: Notice of Intent to File Citizen Suit Under Section 505(b)(1) of the Federal  
Water Pollution Control Act, 33 U.S.C. § 1365(b)

This letter is to give you notice that Oscar Renda Contracting, Inc. ("Oscar Renda") has violated and remains in continued violation of the terms of the Large Construction Storm Water Permit (the "Construction Storm Water Permit")<sup>1</sup> and eight phase-specific Storm Water Pollution Prevention Plans ("Pollution Prevention Plans") associated with the City of East Biloxi Street Repair Program (commonly referred to as "the East Biloxi Street Project"). The areas of the East Biloxi Street Project included in this notice are those in the map included as Exhibit 1. These violations constitute violations of the federal Clean Water Act and the Mississippi Water Pollution Control Law.

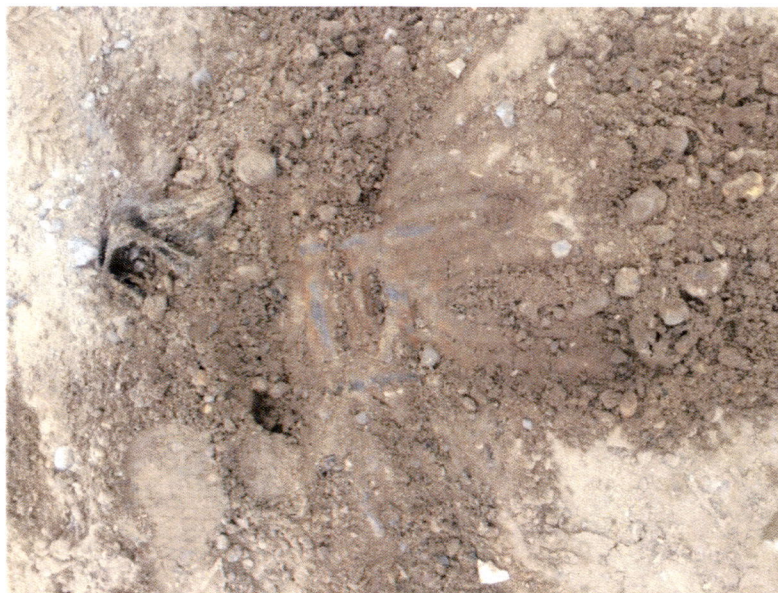
The photograph below shows one of the storm drains in the GRN5 East area which was buried entirely under such a thick covering of hard-packed dirt that referencing the construction map was the only way to locate it.

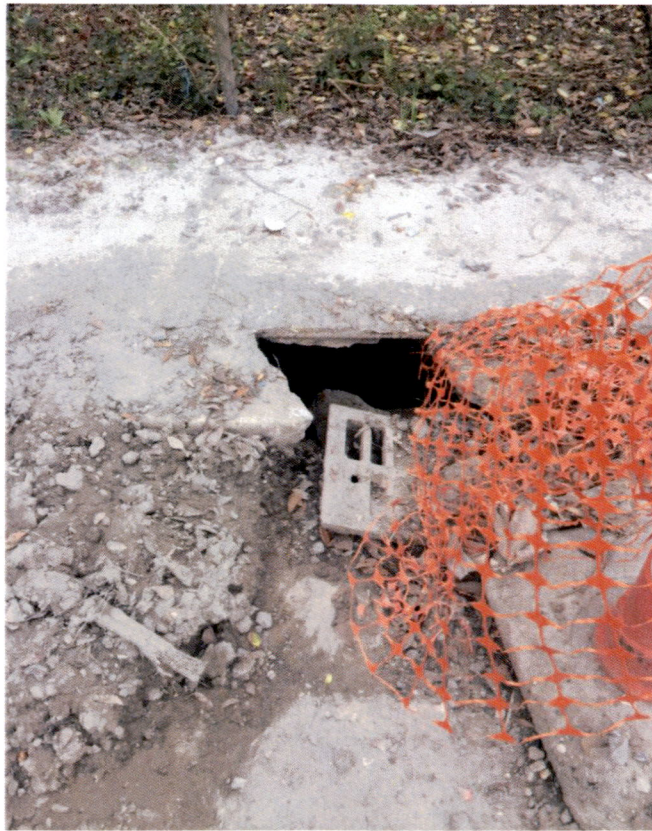
Still other drains are gaping from broken concrete, or have been unattended so long that vegetation is growing in them.

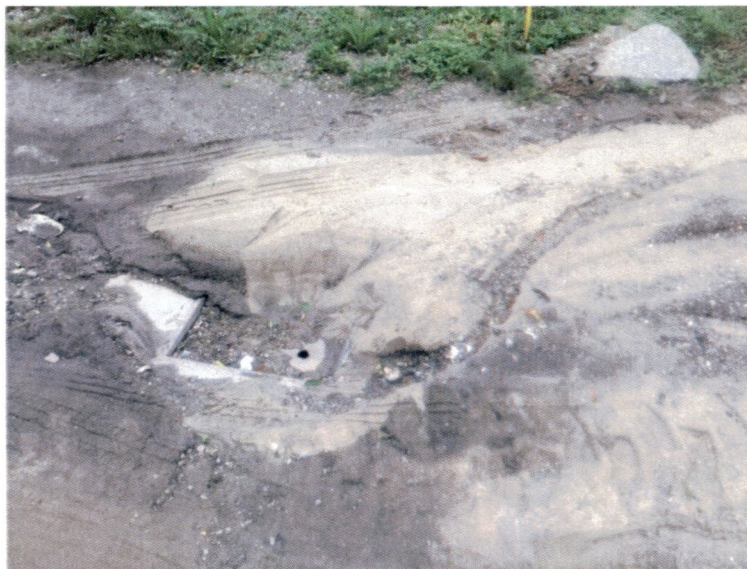
Many of the storm drains in areas of the project still under construction are fully or partially choked with sediment as a result of the lack of pollution controls.

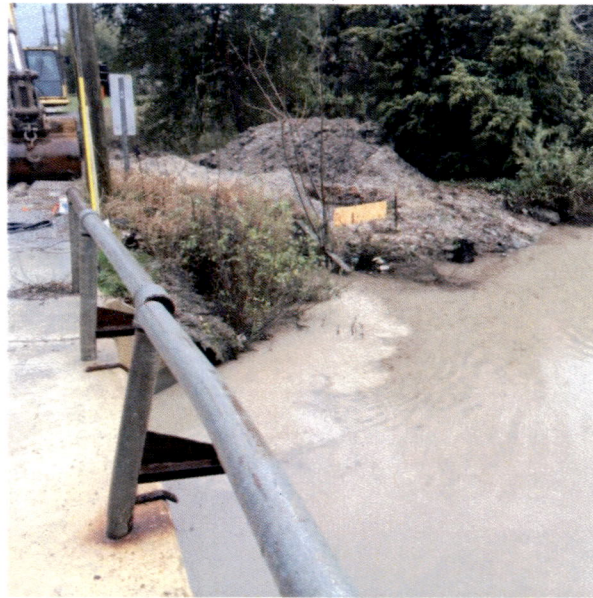
The Construction Storm Water Permit and the Pollution Prevention Plans also require measures such as sediment fencing on the edge of disturbed areas. This type of control is critical to filter sediment out before it can affect aquatic habitats. Oscar Renda's failure to install these simple measures has allowed large amounts of eroded sediment to flow directly into the water bodies adjacent to the project. These flows are so large that they change the color of the receiving waters to a milky brown. The photograph below was taken on February 7, 2017, at Lee Street and Auguste Bayou. It clearly shows a large stream of highly silt-laden water entering a bayou that is already milky with silt from upstream construction on the East Biloxi Street Project.

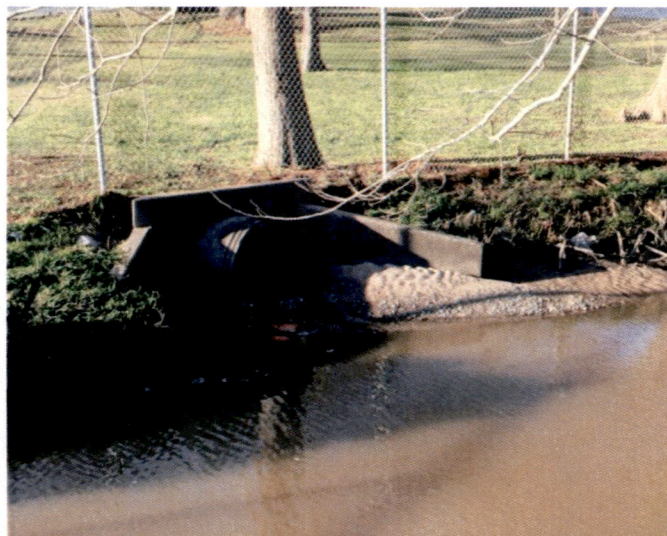
Sediment flows have been so heavy in many areas that large deposits have built up in the receiving waterways, as demonstrated below.

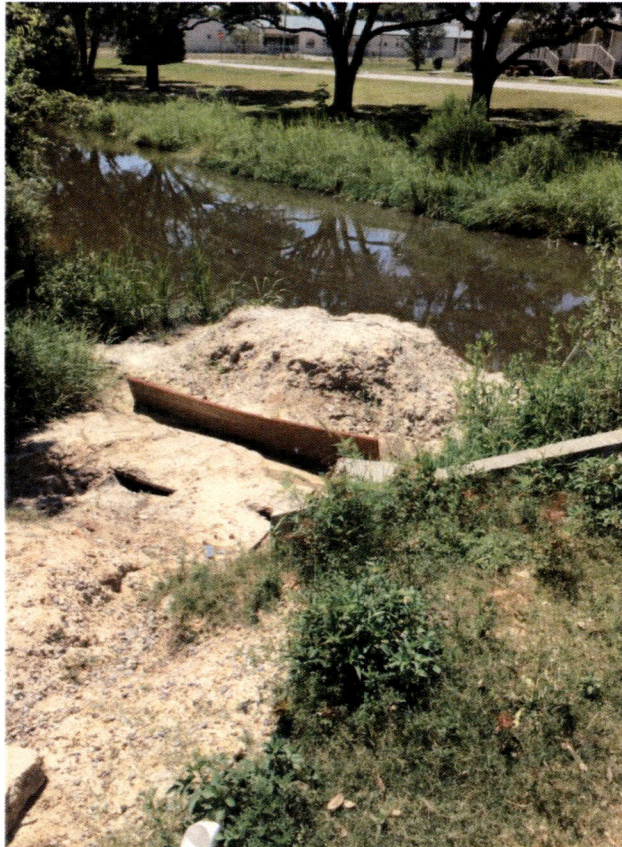
Piles of earth and rock construction material have ineffective or no erosion controls, and have washed into sensitive receiving waters. Some materials appear to have been dumped directly into navigable waters, in violation of Section 404 of the Clean Water Act.
